## TECHNICAL SUPPORT MATERIAL

#### Conveyor Upper Wash Arm Falls Out

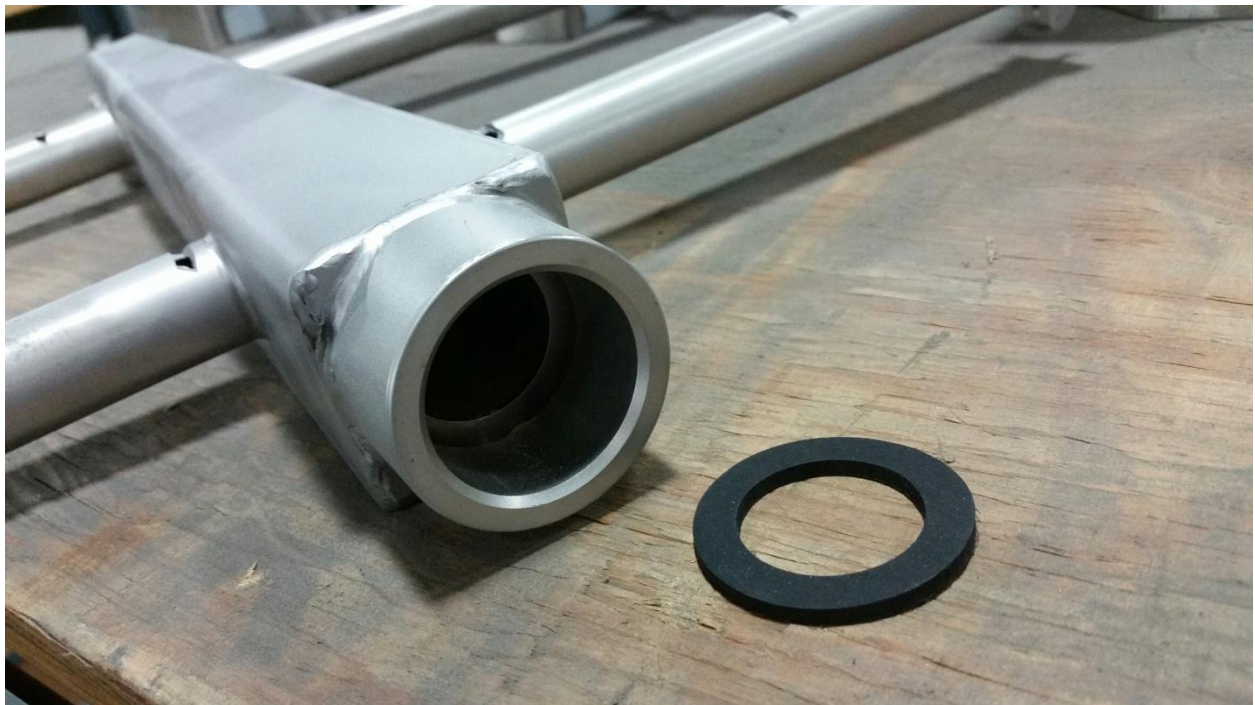
First, inspect the inlet side of the spray arm. There should be a flat rubber washer (289-6608) inserted into an inner channel of the spray arm. If this washer is missing, the arm will slide back on the manifold and fall out of the mount bracket (286-6177).

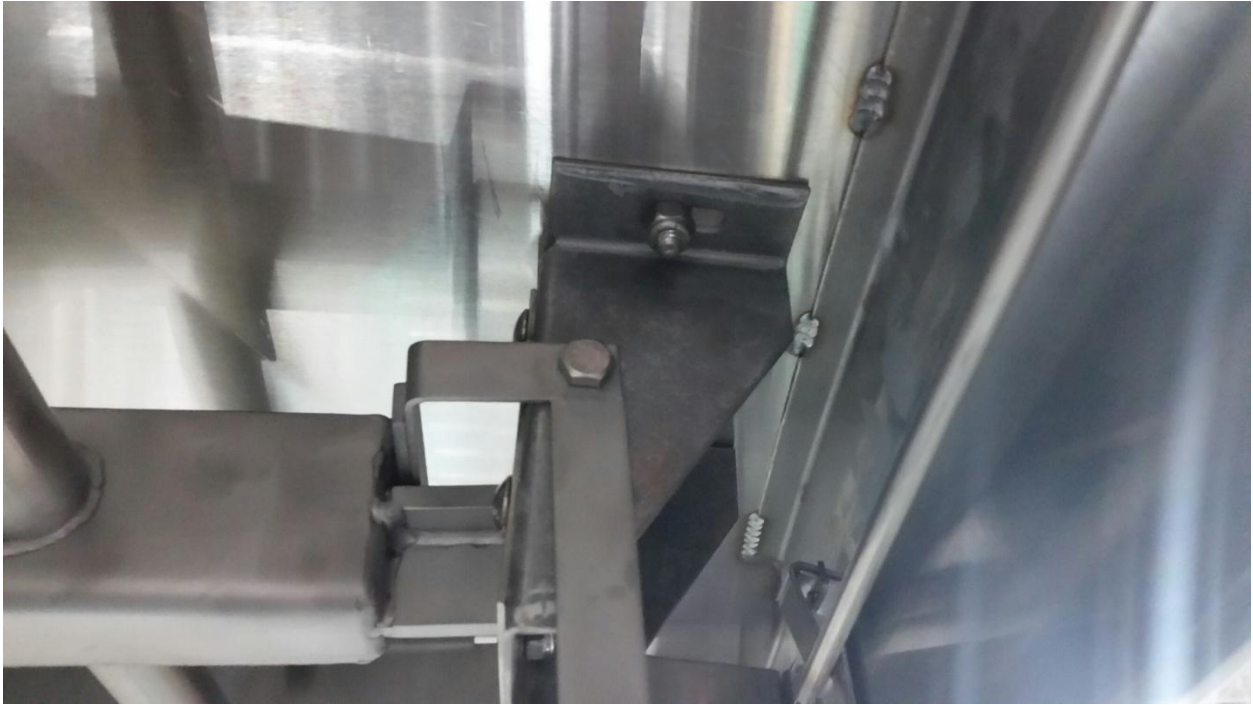
Second, if the wash arm has the washer properly installed inspect the upper wash arm mount bracket (289-6177). It is attached to the hood with weld studs. The correct position should be tensioned against the spray arm when the upper mount handle (285-6129) is pulled down against the spray arm end notch. If this

is a loose handle in the down position, loosen the nuts holding the bracket and slide the bracket toward the spray arm until the handle comes down tight. This locks the spray arm to the manifold.
